SEVERITY OF SIDEWALK IMPEDIMENTS THROUGHOUT HARRISONBURG

CONCENTRATION OF ADA RAMPS THROUGHOUT HARRISONBURG

ADA RAMP ACCESSIBILITY CONDITION THROUGHOUT HARRISONBURG

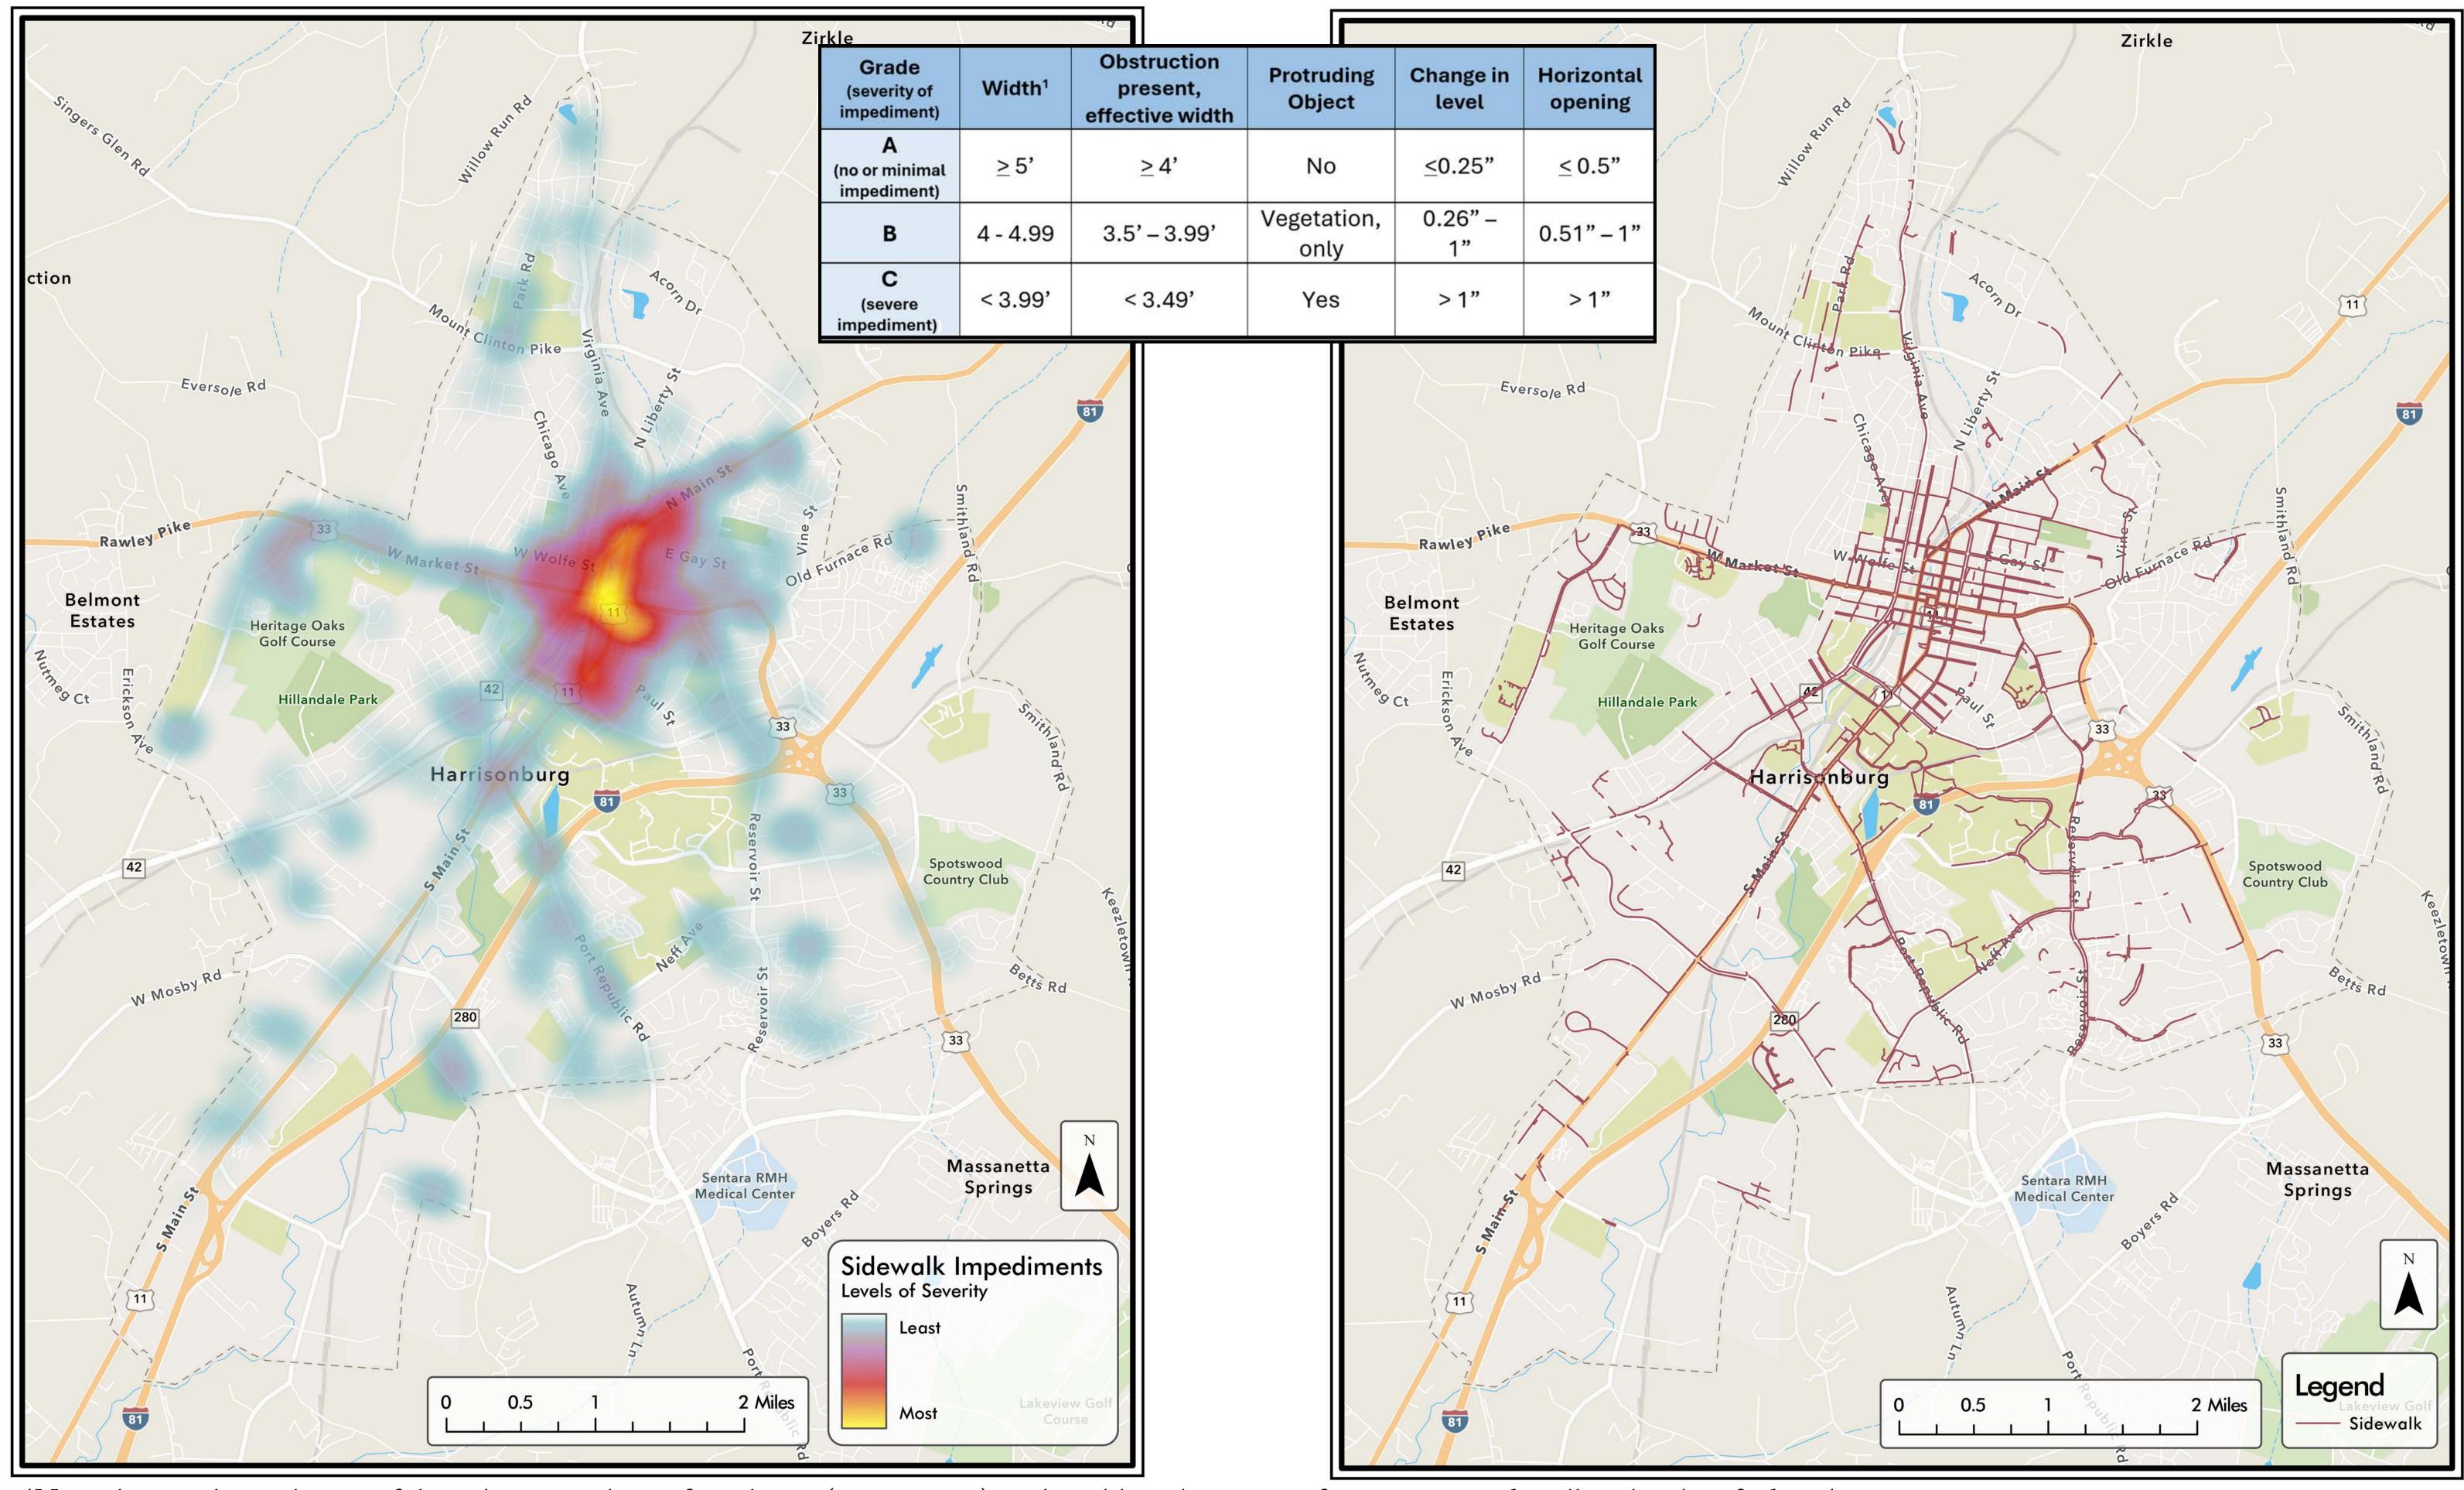
Grade (severity of impediment)	Width ¹	Obstruction present, effective width	Protruding Object	Change in level	Horizontal opening
A (no or minimal impediment)	≥ 5'	≥ 4'	No	≤0.25"	≤ 0.5"
В	4 - 4.99	3.5' – 3.99'	Vegetation, only	0.26"- 1"	0.51" – 1"
C (severe impediment)	< 3.99'	<3.49'	Yes	> 1"	> 1"

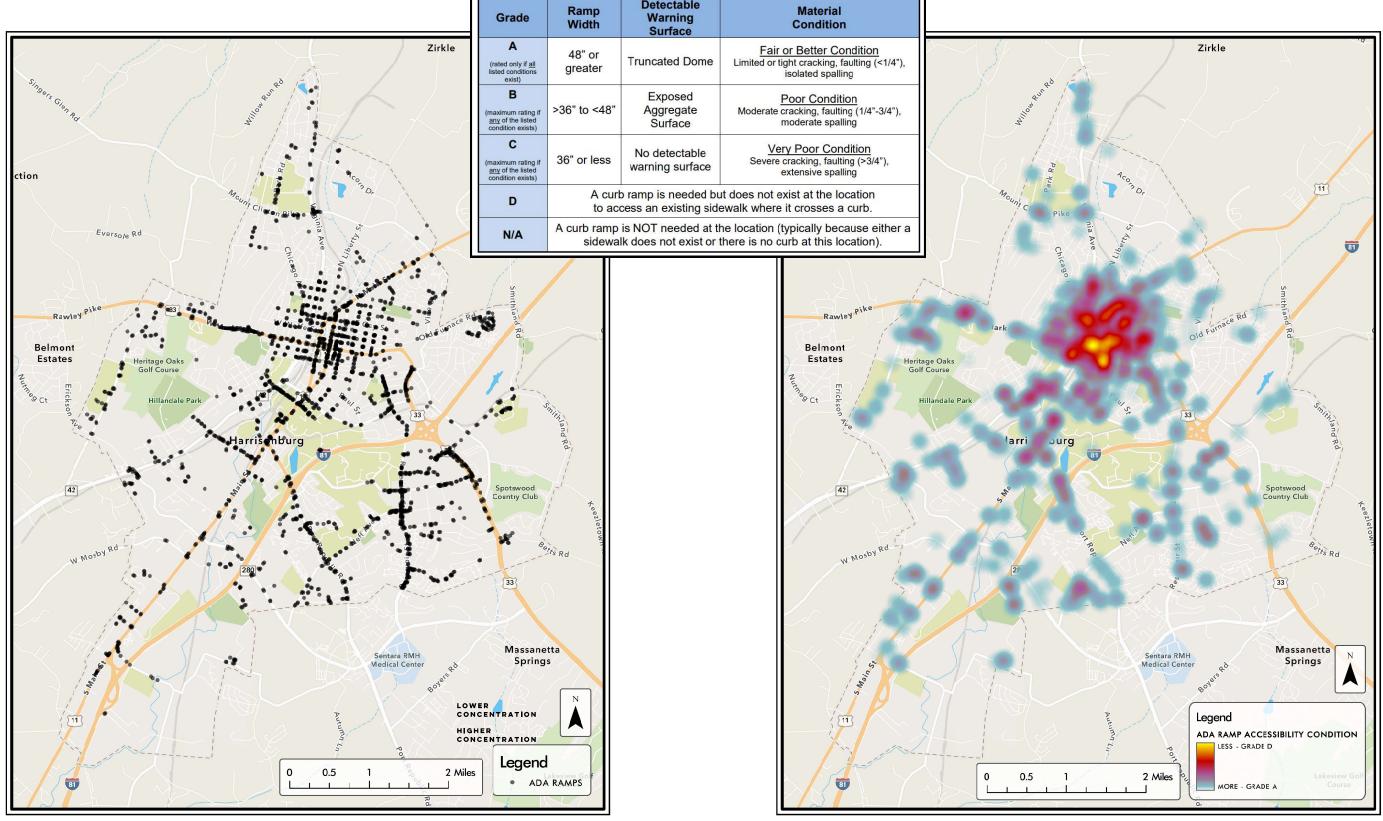
Width	Warning Surface	Condition			
(rated only if <u>all</u> listed conditions exist)	48" or greater	Truncated Dome	Fair or Better Condition Limited or tight cracking, faulting (<1/4"), isolated spalling			
maximum rating if any of the listed condition exists)	>36" to <48"	Exposed Aggregate Surface	Poor Condition Moderate cracking, faulting (1/4"-3/4"), moderate spalling			
maximum rating if any of the listed condition exists)	36" or less	No detectable warning surface	Very Poor Condition Severe cracking, faulting (>3/4"), extensive spalling			
D	A curb ramp is needed but does not exist at the location to access an existing sidewalk where it crosses a curb.					
N/A	A curb ramp is NOT needed at the location (typically because either a sidewalk does not exist or there is no curb at this location).

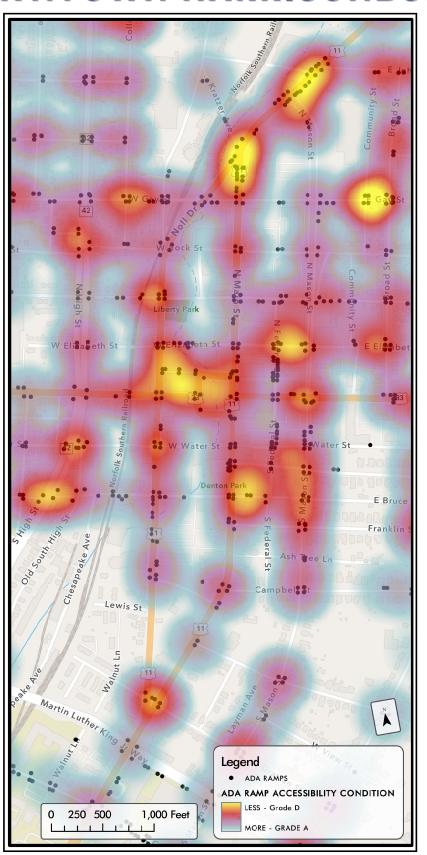
ADA RAMP ACCESSIBILITY CONDITION DOWNTOWN HARRISONBURG

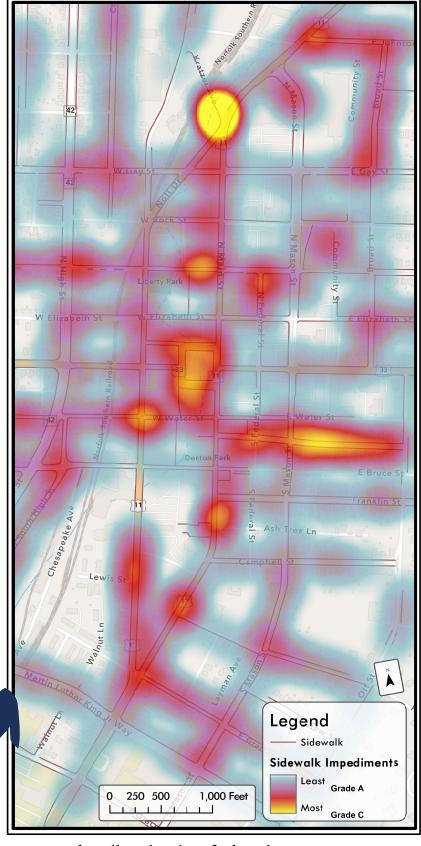
SIDEWALK IMPEDIMENTS DOWNTOWN HARRISONBURG
